Seismic damage analysis of the morisada building, SSRC Annual Meeting Proceedings, 1984. M.S. thesis

SEISMIC DAMAGE ANALYSIS OF THE MORISADA BUILDING

Le-Wu Lu¹ and Shiunn-Jang Wang²Introduction

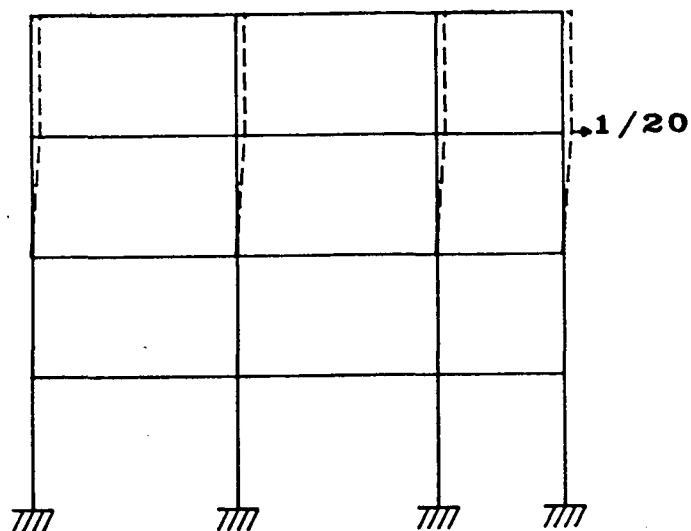
Fig. 2 Observed Permanent Sway

The major damage observed after the earthquake was a very large permanent deflection in the N-S direction between floor levels 2 and 3. This is illustrated in Fig. 2. The permanent deflection amounted to about 1/20 of the story height. Also a relative displacement of 13cm was measured over the clear height of one of the C3 columns (Fig. 3). The column yielded extensively at the two ends, where flange local buckling was also observed. The excessive distortion led to shear failure of the exterior walls and cracking of the window glasses and partitions in the third floor. Some cracks were also found around the column footings.

1. The observed large permanent deflection in the third story is due primarily to the high flexibility of the structure and the sudden change of story stiffness.
2. The inelastic seismic analyses predicts very well the damage pattern. The calculated permanent sway is in fair agreement with the observed value, considering the uncertain nature of the ground motion actually experienced by the building.
3. The dynamic characteristics of the structure may have been significantly affected by overall instability (P- Δ effect).
4. Moment-resisting frames designed by the weak-column, strong-girder concept may experience large inter-story sway during a strong earthquake.

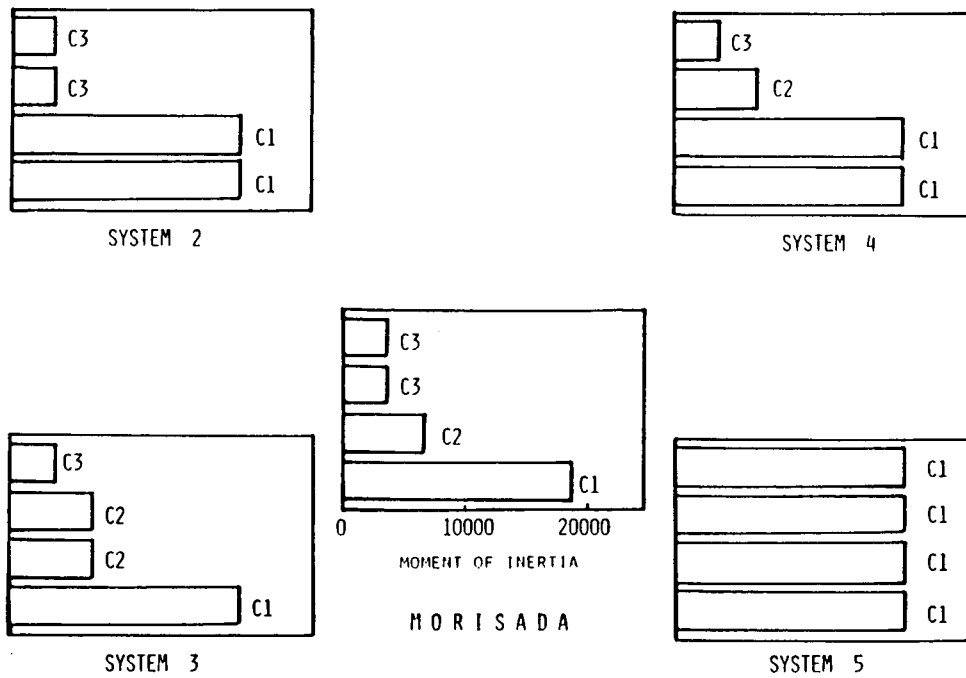
Fig. 7 Column Sizes in Modified Morisada Building Frames

One way to improve the structural response of the moment-resisting frame is to increase its column sizes. The idea is to force more plastic hinges to form in the girders and to distribute the plastic deformation more uniformly throughout the structure (instead of concentrating in a particular story). Four schemes of increasing column sizes have been investigated; they are shown in Fig. 7. The original three-bay frame of the Morisada building is shown at the center. In System 2 the C1 columns are extended to the second story and the column schedule becomes C1, C1, C3, C3. In this case, the third story remains to be the weakest story. In System 3, the C2 columns are extended to the third story, making the second story to be the most critical story. The column schedule is C1, C2, C2, C3. System 4 is a combination of Systems 2 and 3, with the following column schedule: C1, C1, C2, C3. The weakest story is again the third story, but it should be stronger than the third story of the original structure and of System 2.

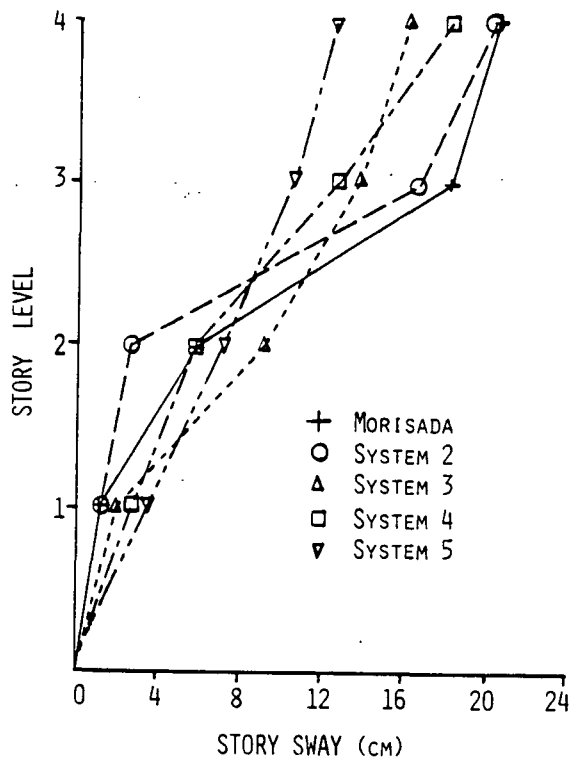
Fig. 8 Story Deflections at Maximum Response

In System 5, the C1 column is used for all the stories. The results of the study are summarized in Fig. 8, in which the floor level deflections at the maximum response are given. The original frame shows a substantial increase of lateral deflection in the third story. This is consistent with the observed large permanent deflection in that story. For System 2, the deflection profile is only slightly changed and structural damage may again be concentrated in the third story. The behavior of System 3 is improved somewhat (less roof deflection) with perhaps smaller permanent deflection occurring in the second story. System 5 has the best performance with almost all the plastic hinges forming in the girders. It is a strong-column, weak-girder structure. The locations of the plastic hinges in the five structures are shown in Fig. 9.
